**REBUILDING OF THE SAGRAH SCHOOL  
UNDER THE COMMANDER'S EMERGENCY RESPONSE PROGRAM  
SAGRAH, ANBAR PROVINCE, IRAQ**

**SUSTAINMENT ASSESSMENT**

**SIGIR PA-08-140  
APRIL 15, 2009**

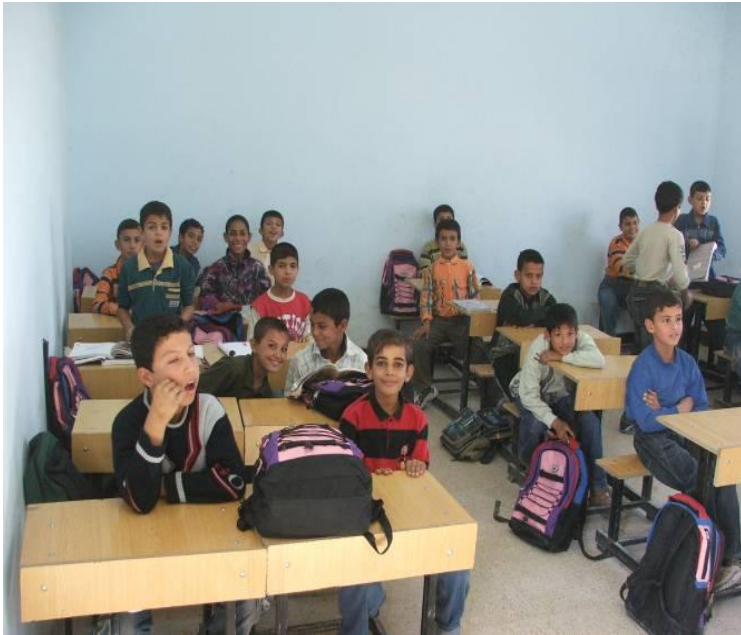
At the time of the site visit (mid-morning), primary students were attending school. SIGIR observed students in class and other children participating in physical education in the schoolyard (Site Photos 1 and 2).

**Site Photo 1. Students in a newly constructed classroom**

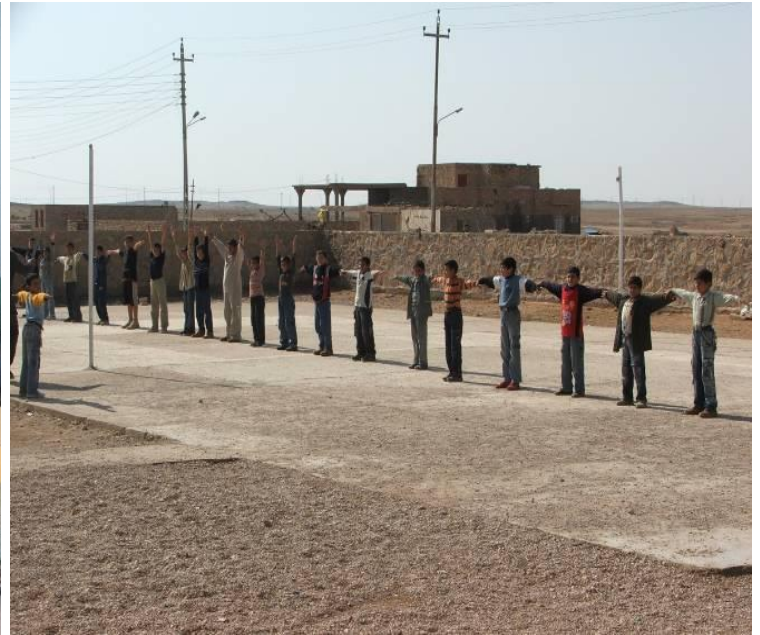
**Site Photo 2. Students engaged in physical education**

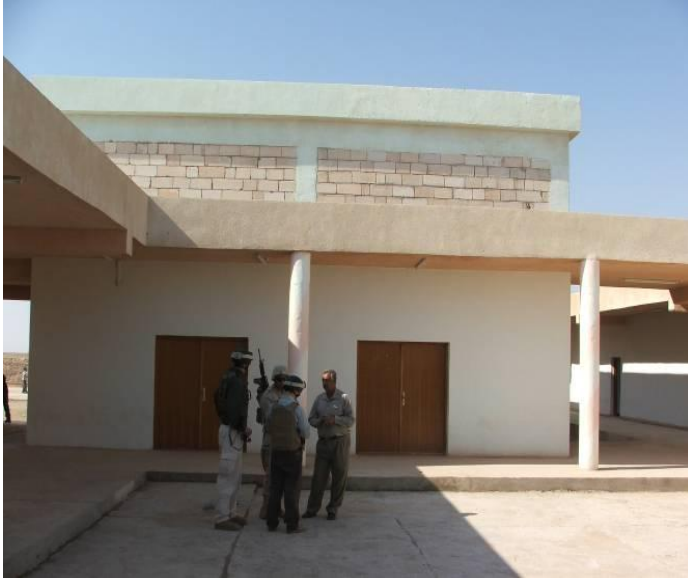
Both the new and existing construction appeared sound. The reinforced concrete frame of the new construction was exposed and appeared to be adequate, with no apparent or noticeable defects (Site Photo 3). Several sections of the new construction had exposed concrete masonry units, which appeared to be of above average quality (Site Photo 4).

**Site Photo 3. Structure with reinforced concrete frame**

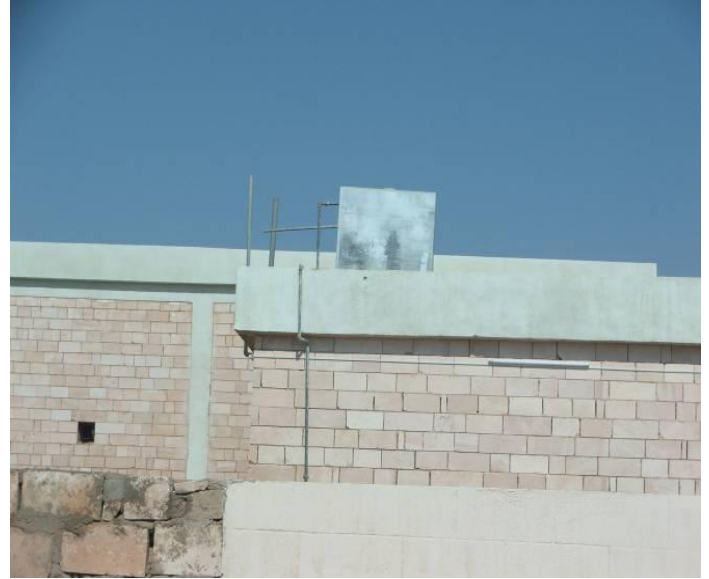
**Site Photo 4. Exposed concrete masonry units**

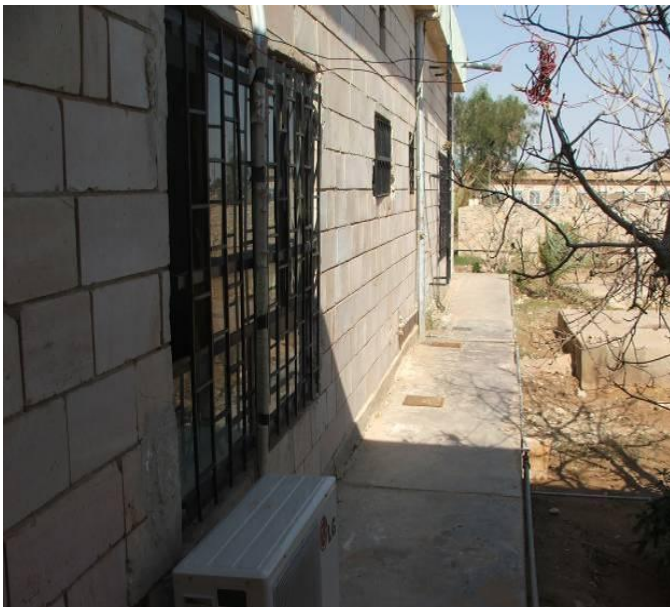
The doors and hardware were installed and functioning. The window glazing appeared to be intact, and latching hardware had been installed (Site Photo 5). The concrete courtyard appeared to be well constructed with no areas of settlement or indications of ponded water (Site Photo 6).

**Site Photo 5. Newly constructed exterior windows**

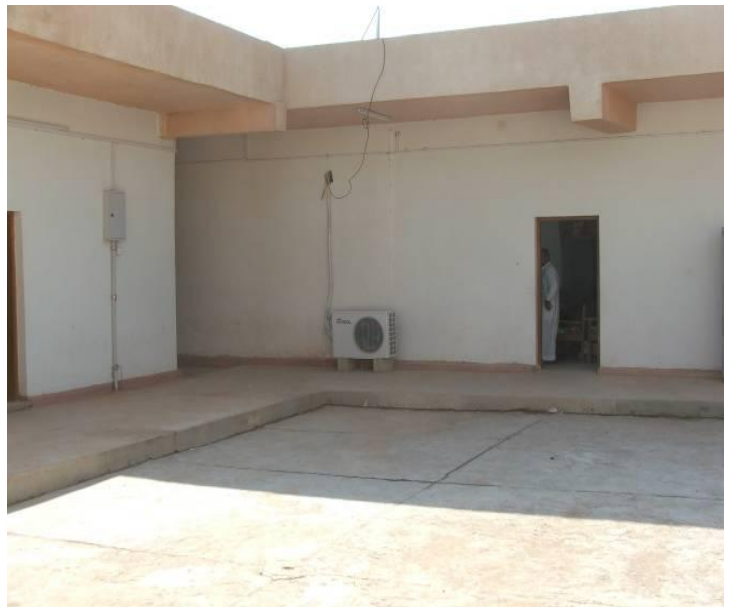
**Site Photo 6. School courtyard**

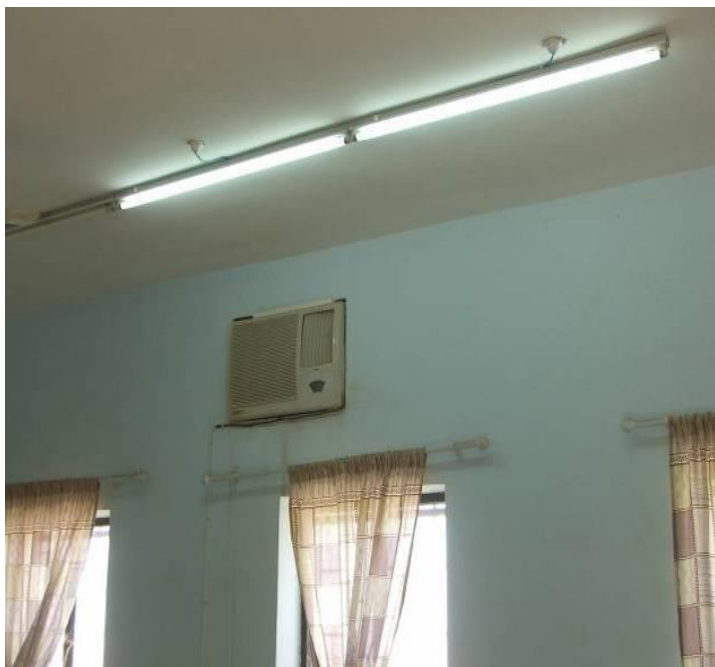
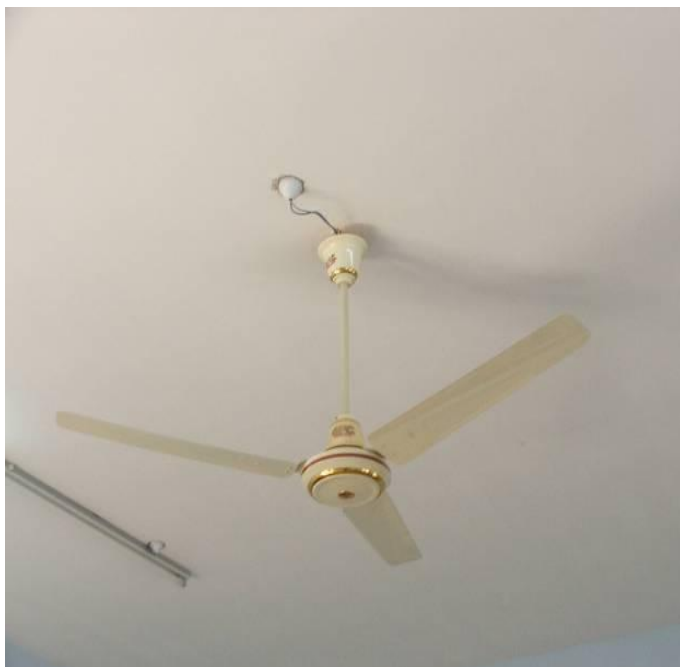
The electrical components were installed and functioning. Most of the wiring was installed in conduits and appeared adequate. Also, the main power panel, fluorescent lighting, and ceiling fans were properly installed (Site Photos 7 and 8).

**Site Photos 7 and 8. Fluorescent lighting and ceiling fans inside each classroom**

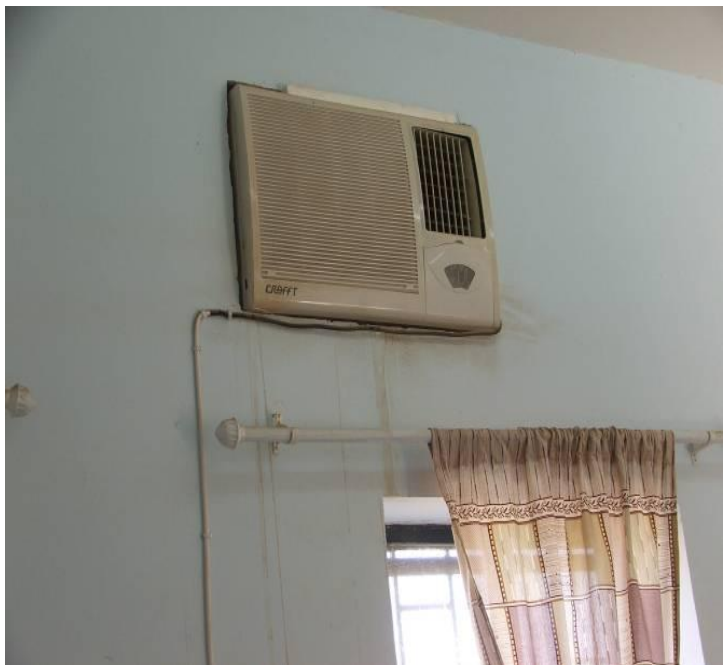
SIGIR observed two types of air-conditioning units installed at the school. The majority of the classrooms were cooled by wall mounted units (Site Photo 9); while some were cooled by split air-conditioning units (Site Photo 10).

**Site Photo 9. Wall mounted air-conditioning unit**

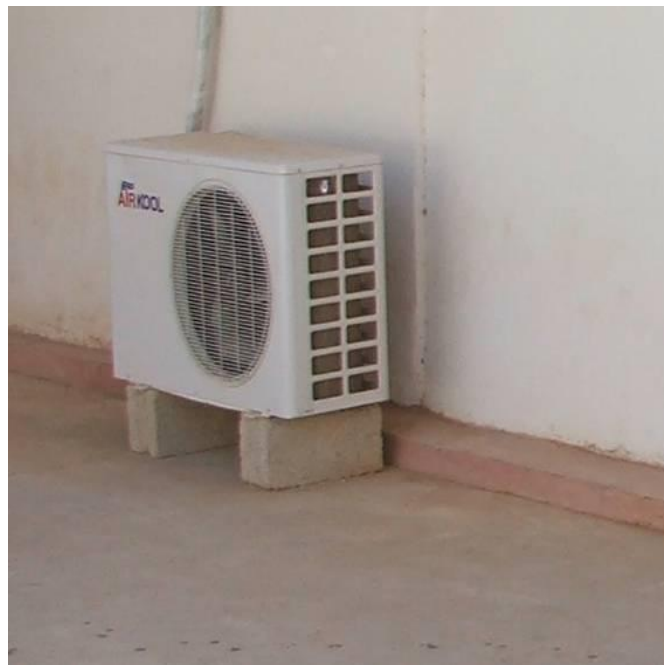
**Site Photo 10. Split air-conditioning unit**

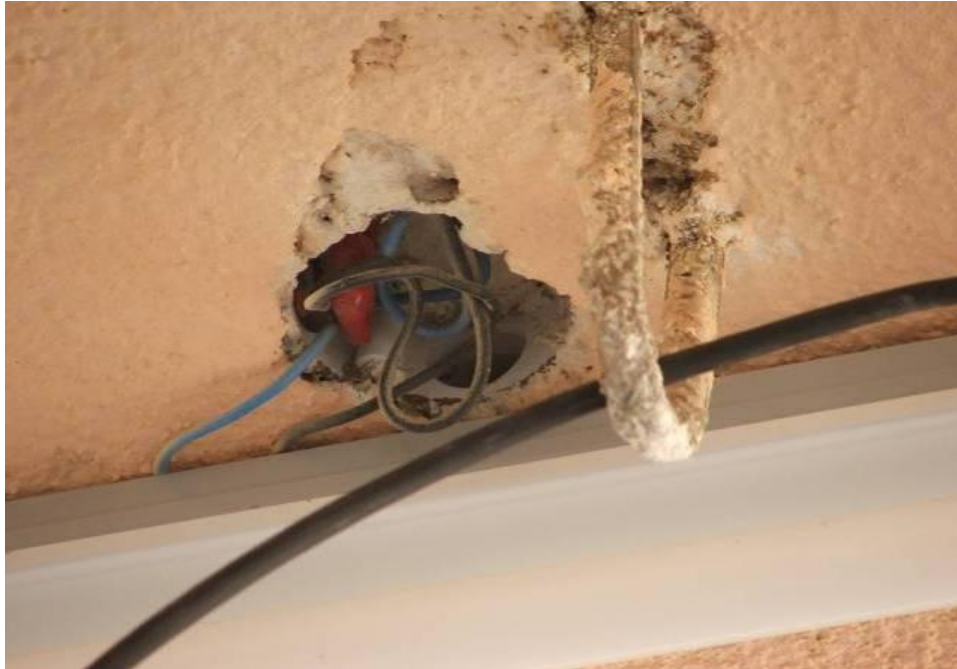
SIGIR noticed several deficient wiring connections (Site Photo 11), which have the potential to short circuit and create a hazard for electrocution and fire.

**Site Photo 11. Example of deficient and potentially hazardous electrical connections**

The electrical components were installed and functioning. Most of the wiring was installed in conduits and appeared adequate. However, SIGIR noticed several inadequate wiring connections, which have the potential to short circuit and create a hazard of electrocution and fire; however, it appeared these connections were likely done subsequent to the work performed by the contractor.

MNF-W issued a letter to the Deputy Governor, Office for Technical Affairs, Al Anbar province, referencing an existing operation and maintenance agreement requiring the Government of Iraq to provide preventive maintenance to facilities rehabilitated or constructed by the U.S. government. MNF-W requested the Deputy Governor's assistance to "correct the deficiencies in the [electrical] wiring and lavatories to protect the students and faculty from harm."

SIGIR appreciates the concurrence by MNF-W to the construction deficiencies identified in the draft report. SIGIR agrees the Government of Iraq needs to address the electrical wiring and lavatories in order for this facility to function safely and at optimal capacity.

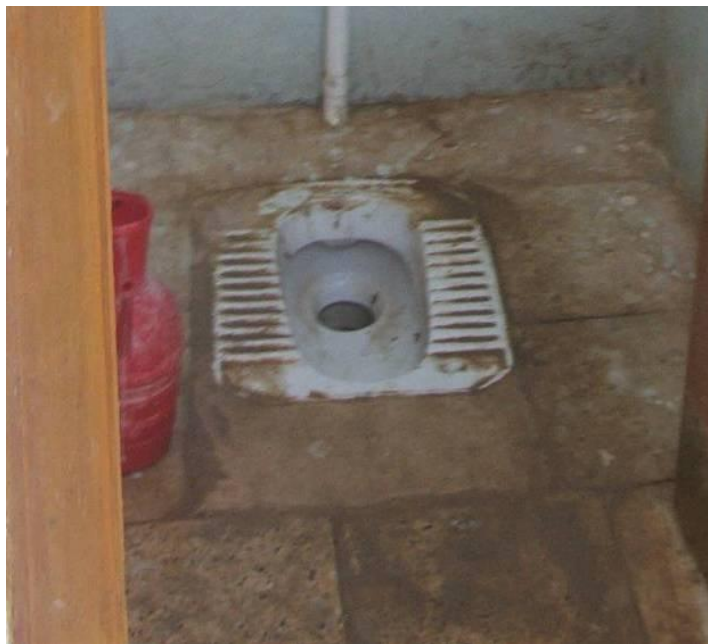
During the site visit, SIGIR inspected the newly constructed restroom facility and septic holding tank. The restrooms were supplied with eastern-style toilets, which appeared to function (Site Photo 12).

**Site Photo 12. Eastern-style toilet**

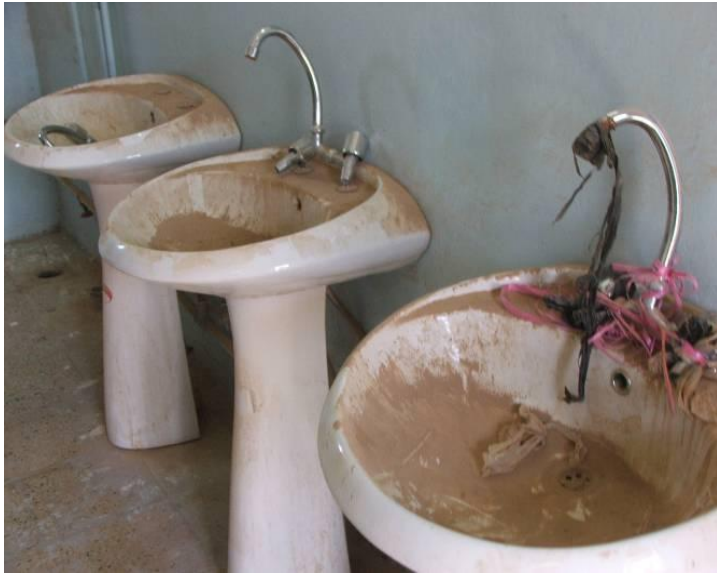
Individual lavatories were installed in the restrooms; however, there were signs of abuse and most did not function (Site Photo 13). While most lavatories appeared to be connected to the septic holding tanks, SIGIR did observe one lavatory discharging

directly into the ground. The required hot water heater had been installed (Site Photo 14).

**Site Photo 13. Damaged lavatories**

Individual lavatories had been installed in the restrooms; however, there were obvious signs of abuse and most did not function. Although most lavatories appeared to be connected to the septic holding tanks, SIGIR did observe one lavatory discharging directly into the ground.

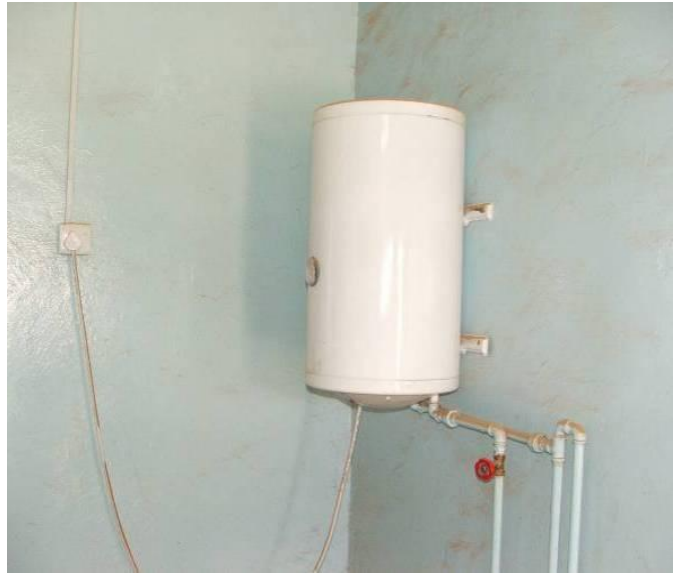
**Site Photo 14. Hot water heater**
